ACCELERATED SHORT SPAN BRIDGE REPLACEMENT USING PRECAST ELEMENTS

Lisa Carter Powell, P.E., President, P.E. Structural Consultants, Inc.
8436 Spicewood Springs Road, Austin, Texas 78759

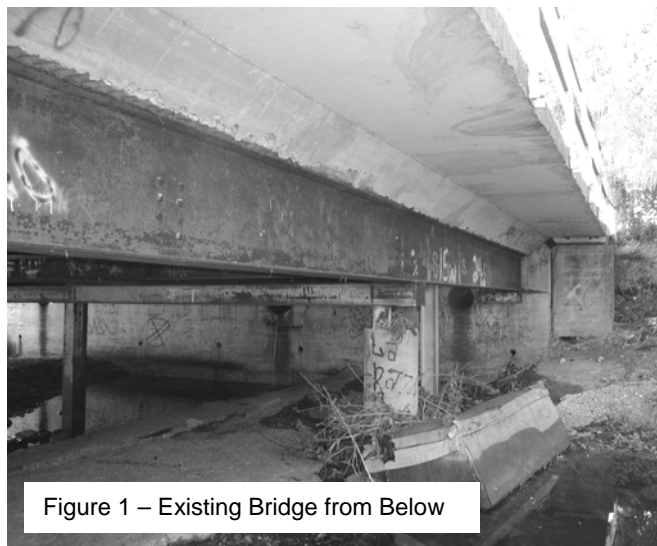
Figure 1 – Existing Bridge from Below

A recent off-system bridge replacement project for the Texas Department of Transportation (TxDOT) involves a structure within a FEMA controlled waterway in Travis County, Texas - West North Loop Bridge over Hancock Branch in Austin. The existing functionally deficient structure (originally constructed in 1939; modified and widened several times over the years) had a 40 foot long steel superstructure that had deteriorated due to age (see Figure 1). In its original configuration, the 24" deep steel I-beams carrying wood deck spanned to vertical concrete retaining wall abutments on spread footing foundations. An interim modification some 20 years later added approximately 10 inches of concrete deck and cantilevered sidewalks, requiring an extension to each side of the

original abutment support wall and the addition of a midspan support. Several large storm sewer pipes had also been retrofit into the abutment retaining walls to divert runoff into the creek. The level of deterioration in the steel stringers and cross beams, the questionable nature of the substructure elements that had been added to the original structure and the presence of lead based paint effectively precluded phased replacement. This bridge had been inundated many times during its design life, but the profile could not be raised significantly due to the proximity of driveways for several businesses lining the roadway. Although detouring vehicular traffic during construction was not a problem, because West North Loop is an urban street that serves as a critical pedestrian route, the City wished to reduce the time the road would be closed. It was also desirable to minimize disruption of the creek channel. The new structure needed to add width for four standard lanes and ADA compliant sidewalks, and improve flow characteristics of the creek through the structure.

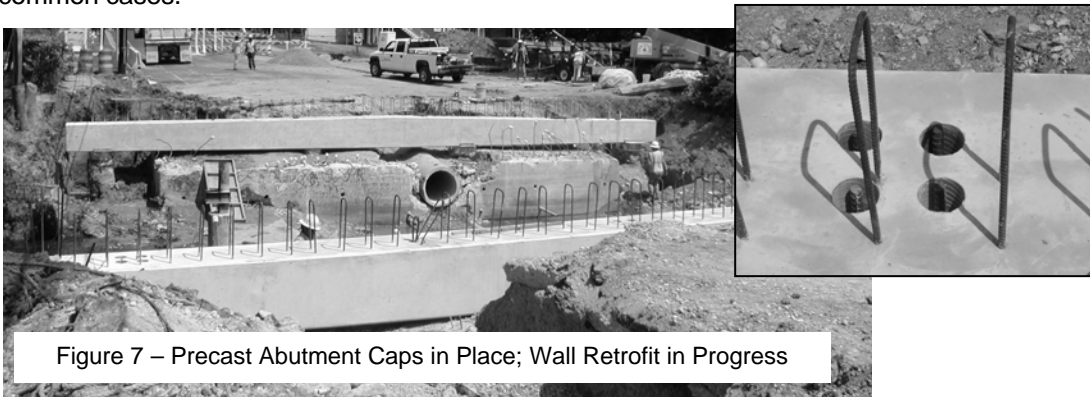
Figure 7 – Precast Abutment Caps in Place; Wall Retrofit in Progress

Another time saving measure involves precasting the two identical abutment caps, allowing fabrication of the caps to proceed simultaneously with the partial demolition and retrofit of the existing retaining wall and other utility relocation work around the abutments. The top of the cap slopes to follow the crown of the roadway, while the bottom of the cap is level, simplifying placement on, and connection to, the supporting drilled shafts. An excellent research report by Masumoto, et al from the University of Texas (3), provides
