THE CONGRESS AVENUE BRIDGE: 100 YEARS OF AN AUSTIN-CHANGING ICON

By Nestor R. Rubiano, PhD, P.E., Structural Consultants, Inc., Austin, TX

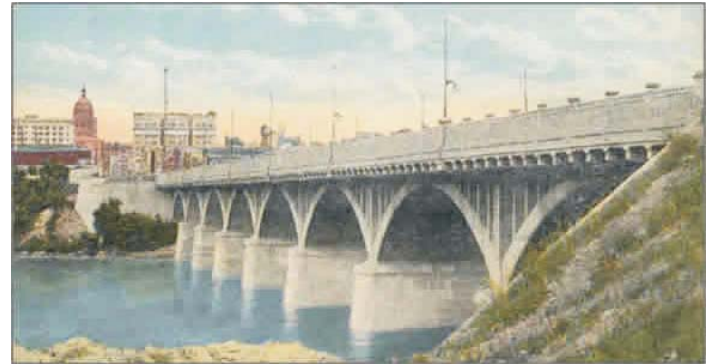
Figure 2 – Congress Avenue Bridge (circa 1940)

In the early twentieth century, it was clear that due to increased traffic, a wider bridge was necessary, so a new concrete bridge was conceived. Figure 2 shows a view of the bridge from the south bank of the river.

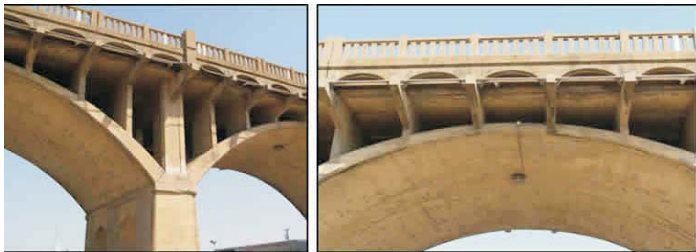
Figure 3 – Structural System of the Congress Avenue Bridge

Spandrel walls initiating at the arches served as supports for the bridge deck (see Figure 3). The Spandrel walls, running transverse to the bridge centerline, are supported by the arches; they are 29.5 ft long by 1.25 ft wide and are spaced at 7.25 ft on center.

On both sides of each spandrel wall, short beam overhangs extended to support the deck beyond the edge of the arches (as shown in Figure 3).

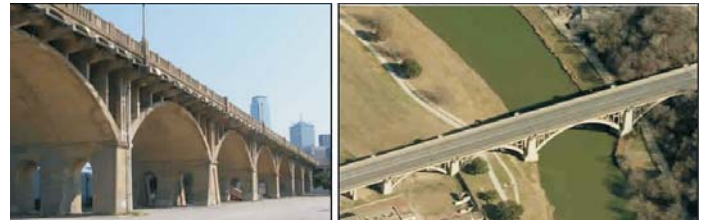
Figure 4 – Houston Street Viaduct (Dallas) and N. Main Street Bridge (Fort Worth)

Several bridges with similar structural systems were built in the early 1900s across Texas. Dallas, Houston and Fort Worth had this type of bridge built to cross rivers and a few of them have been included in historical registries. Figure 4 shows two such bridges that are still in use today: the Houston Street Viaduct in Dallas and the North Main Street Bridge in Fort Worth.

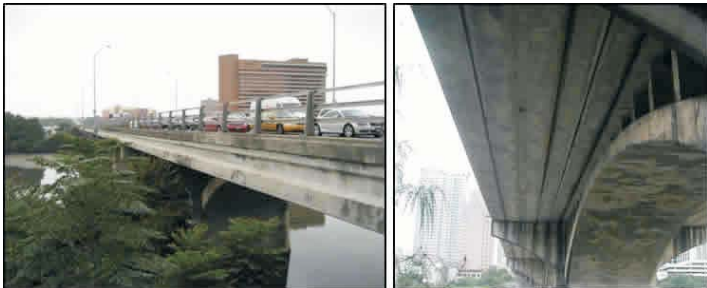
Figure 6 – Precast Concrete Box Beams

Based on the recommendations of this study, the bridge superstructure was replaced and significantly widened between 1977 and 1980, following the provisions of the AASHTO Standard Specification for Highway Bridges (1977 Interim). Precast prestressed box beams were used to entirely replace the original superstructure of the bridge (see Figure 6).

Beams were transversely tied using post-tensioning strands at their 1/5 points and void spaces between beams (shear keys) were filled with structural concrete. A 12-in slotted drain pipe ran below the curbs, embedded in a cast-in-place concrete beam formed between the second and third precast beams from the edge. A 1/2-in two course surface treatment was provided over the 1 1/2-in ACP layer.

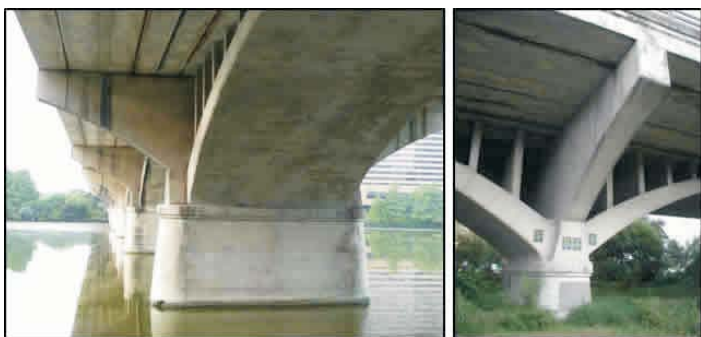
Figure 7 – Pier Cantilever Extensions

The upper part of every pier was removed above elevation 451.0, and the remaining portion of the pier wall was extended by 3.0 ft on either end. A flared reinforced concrete bent cap was added with a base of 36.0 ft and a total length of 81.2 ft at top of cap (Elev. 467.93), generating 22.6 ft tapered cantilevers on both ends. These extensions were necessary to support all the box beams. These modifications effectively transformed the pier walls into deep-cap hammerhead bents. Figures 7 and 8 show these cantilevers.
